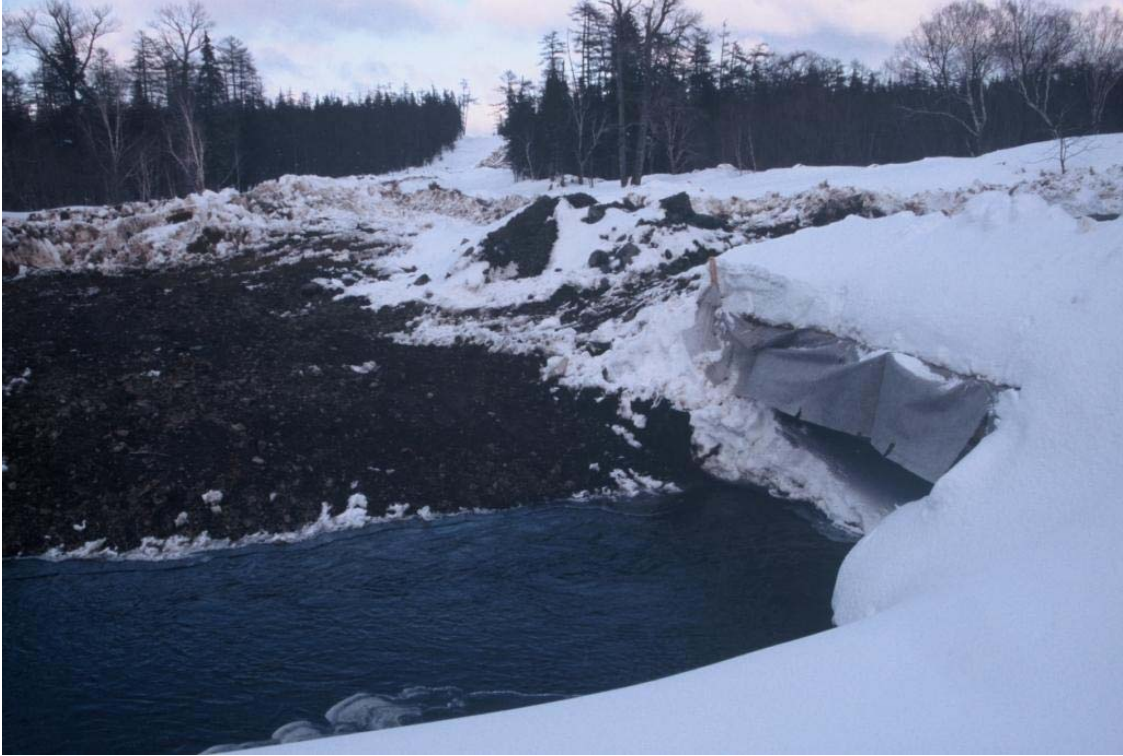
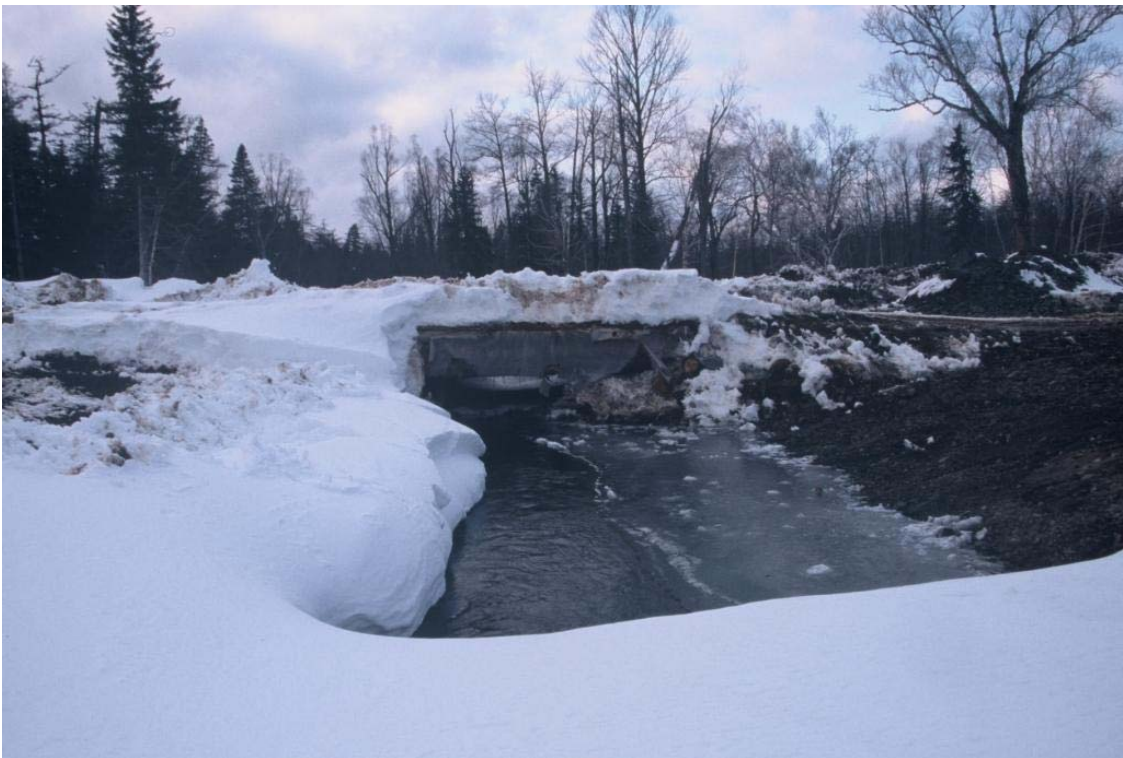
Plelyarna River crossing
April 3, 2006

Unfortunately, the site inspection revealed a different picture. As the attached photos show, the silt fences on the bridge have already collapsed, there are no fences near the river banks, and river banks have not been stabilized to prevent erosion—they are instead exposed soil waiting to be carried downstream by snow melt and spring rains.

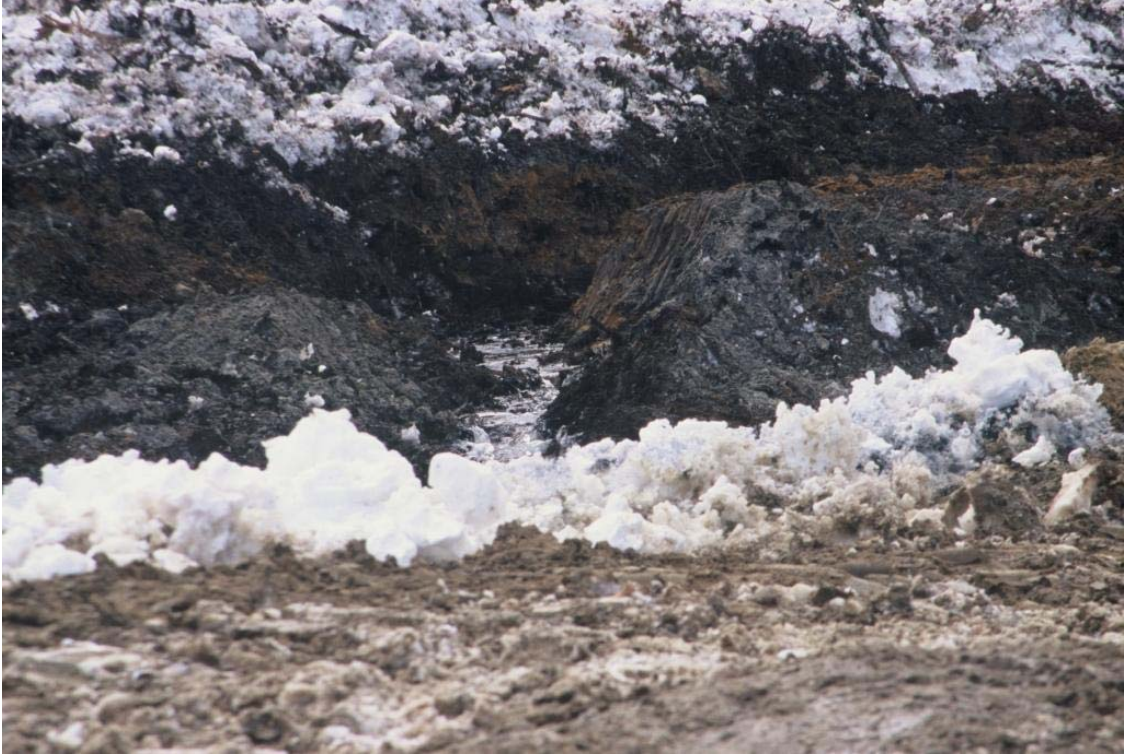
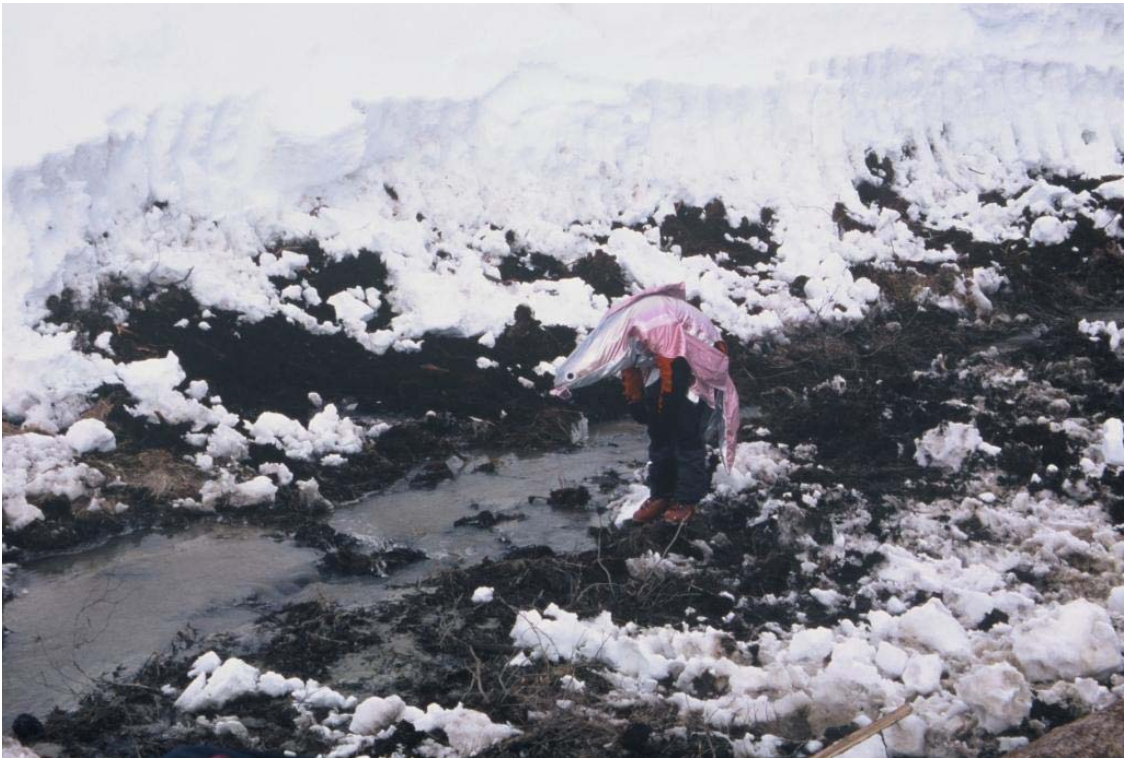
Unknown tributary of the Orkunyy River
April 4, 2006

In April 2006, Wild Salmon Center program assistant Nicole Portley skied 115 km along the pipeline route. Along the way she saw several problematic areas, including unchecked sediment flows in an unknown tributary of the Orkunyy River (approximately KP 6). Most troubling is the Plelyarna River crossing site. The gas pipeline crossing was built on January 24. The associated River Crossing Monitoring Checklist states that all temporary soil erosion control measures were installed, including silt fences and bank protection measures.
